ICE CUTTER STERN TUBE OIL DEHYDRATION

United States Coast Guard.

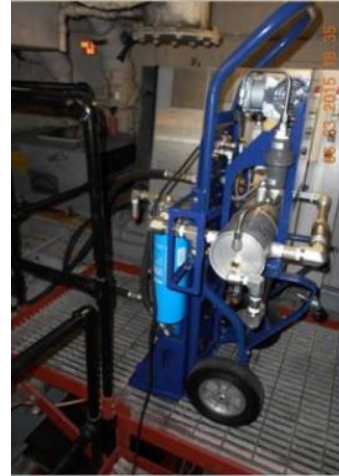
Dehydration system in hull of USGC Waesche

Coast Guard rented a large dehydration system in an effort to avoid premature lubricant changeover. Unit was attached directly to the 1300 gallon lubrication oil reservoir in a kidney loop operation.

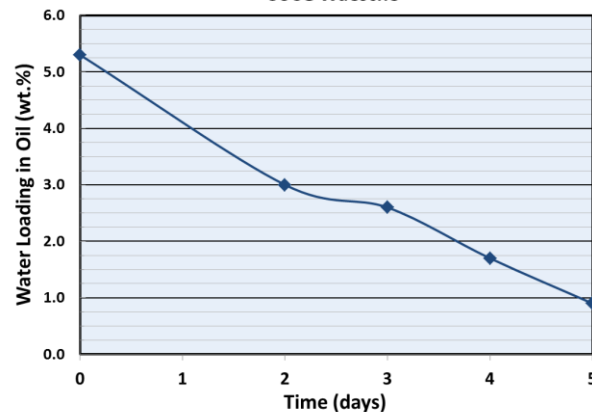
By 5 days the water loading was reduced to below 1 wt% as measured by Karl Fischer titration. Oil changeover was still necessary due to presence of degradation products. Coast Guard chose to employ dehydration systems in other vessels using same hydraulic oil.

Dehydration Profile of 1300 gallon lubricant reservoir in USCGC Waesche

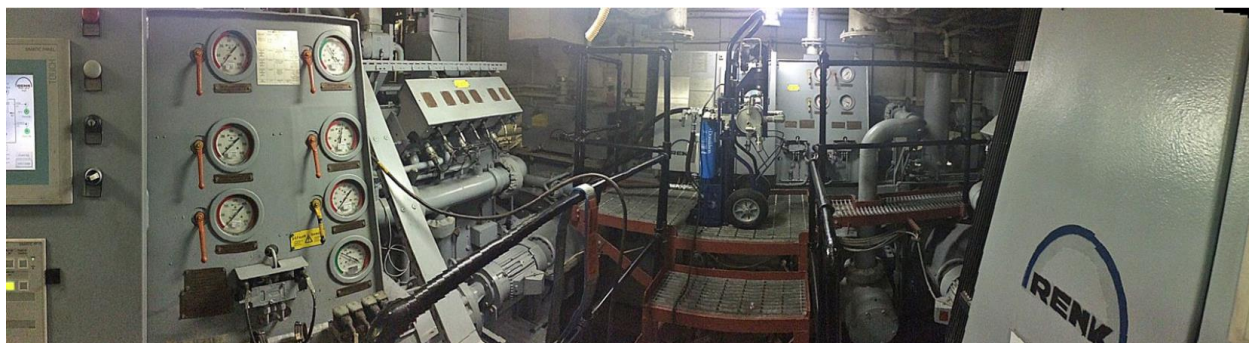
Dehydration system size compared to other hull equipment
